# PROJECT PROFILE

## FORENSIC EVALUATION OF FLOOR SLAB CRACKING AND GROUND HEAVE

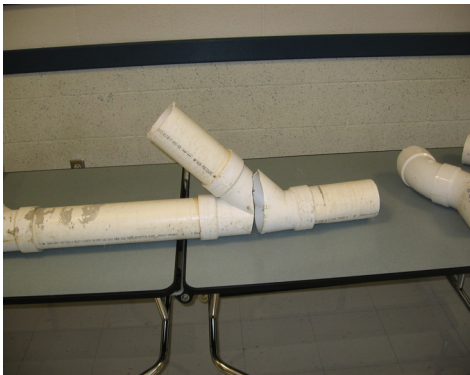
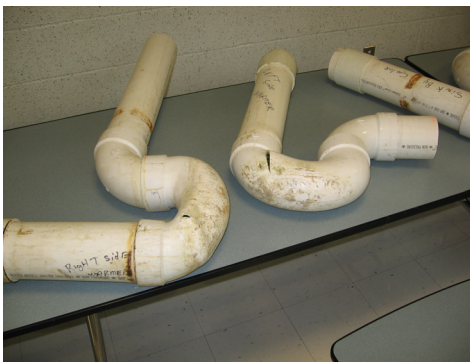
Examples of damaged PVC pipe from building crawl space.

expansive shale caused damage to utilities in the crawl space below the first floor slab, which served to exacerbate the heave effects. Some of the damaged utility lines had already been replaced. Our study indicated that visible cracking of concrete building floors and masonry walls was not the result of heave, but due to differential displacements in and between building structural elements of varying stiffness, including rigid reinforced-concrete grade beams and relatively flexible structural steel members. We also concluded that exposure and heating of the ground in the crawl space under a boiler room in the building, leakage from storm/sanitary sewer drain lines, and poor surface drainage control contributed to the observed expansion/heave of the shale.

- Remove reacted shale in affected crawl space areas.
- Coat excavated surfaces with bituminous material or a vapor barrier.
- Insulate the crawl space from boiler room heat.
- Relocate utilities that could potentially be affected by future expansion.
- Monitor the water main for leakage.
- Improve surface drainage around the building.
- Monitor the crawl space periodically for heave.

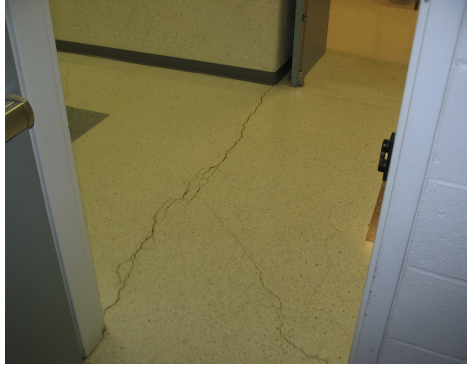
Cracking observed in school building floor.

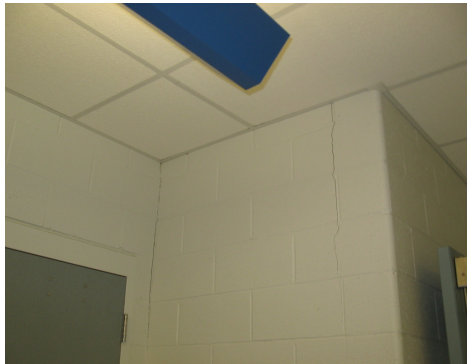
Cracking observed in school building wall.

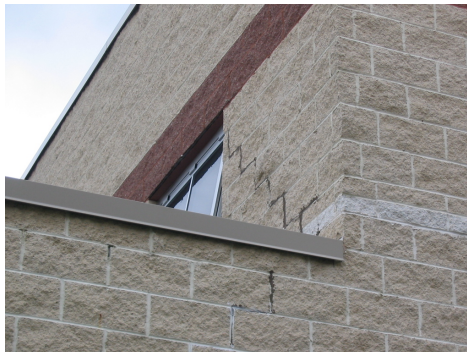
Cracking observed in exterior walls.

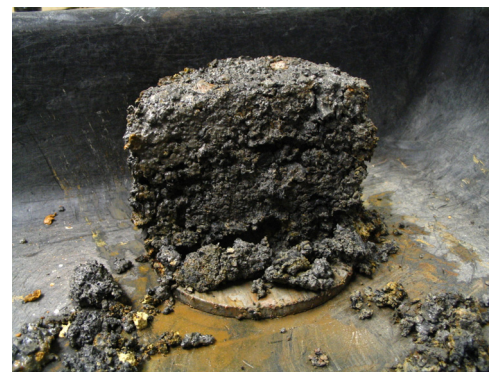
Portion of pyritic shale sample following laboratory free swell test.
