# PROJECT PROFILE

## GROUND PENETRATING RADAR EVALUATION OF ARCH-CULVERT TUNNELS

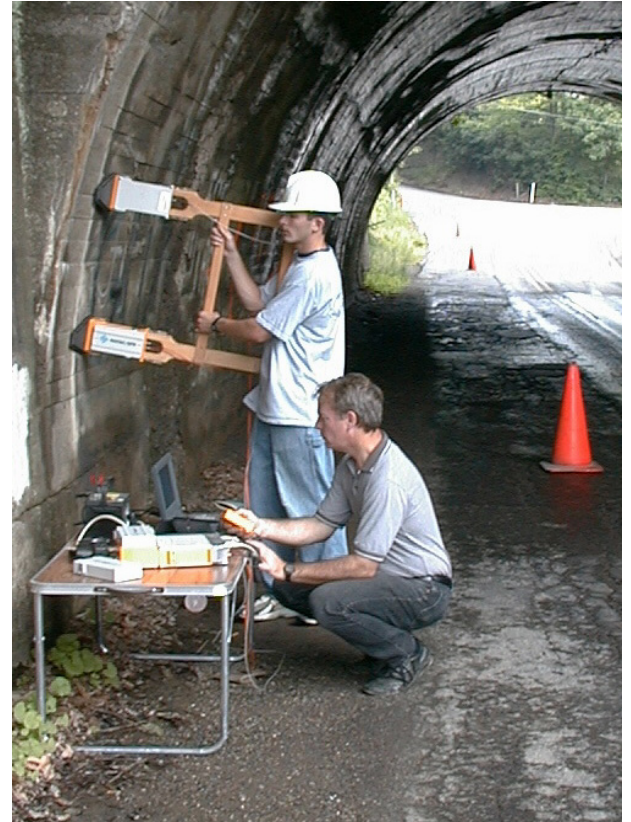
Non-destructive testing of concrete with Ground Penetrating Radar (GPR) at Rich Hill Road test site.

The RAMAC 2 GPR system with 200-MHz antennas manufactured by Malå Geosciences in Sweden was used to image the concrete in the roadway tunnel. The data obtained from the GPR survey indicated that meaningful results could be obtained to an effective depth of penetration in the range of 20 to 40 inches below the surface.

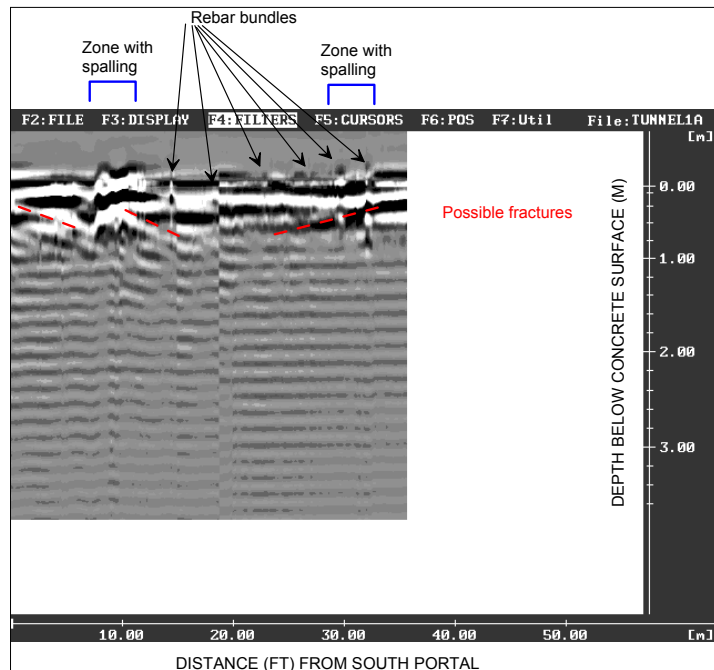
GPR profile of Rich Hill Test site taken parallel to the tunnel axis from the south portal one meter from the tunnel floor. The record indicates the presence of reinforcing bars and possible fractures.

Observed GPR reflections arriving at a shallow angle to the tunnel surface were interpreted to be fractures in the concrete. Sharp disturbances in the signal were interpreted to be reinforcing bars.
