PROJECT PROFILE

FORENSIC ANALYSIS AND REDESIGN OF FAILED ROCK SLOPE

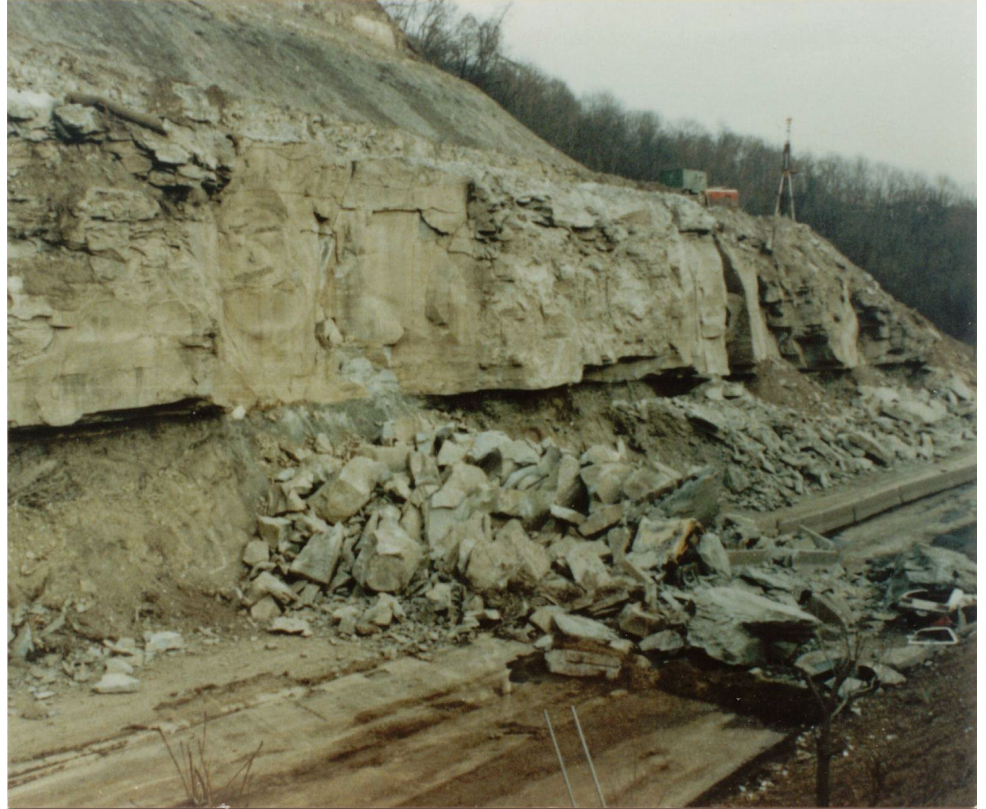
A more than 100-foot-high rock slope on the south face of Mt. Washington along State Route 51 (Saw Mill Run Boulevard) in Pittsburgh, Pennsylvania failed killing a bulldozer operator who was working at the site and two motorists who were passing the site when the rock slope failed. At the time of the failure, the slope was being repaired in accordance with a design prepared by others.

One hundred-foot-high rock slope along Saw Mill Run Boulevard following failure.

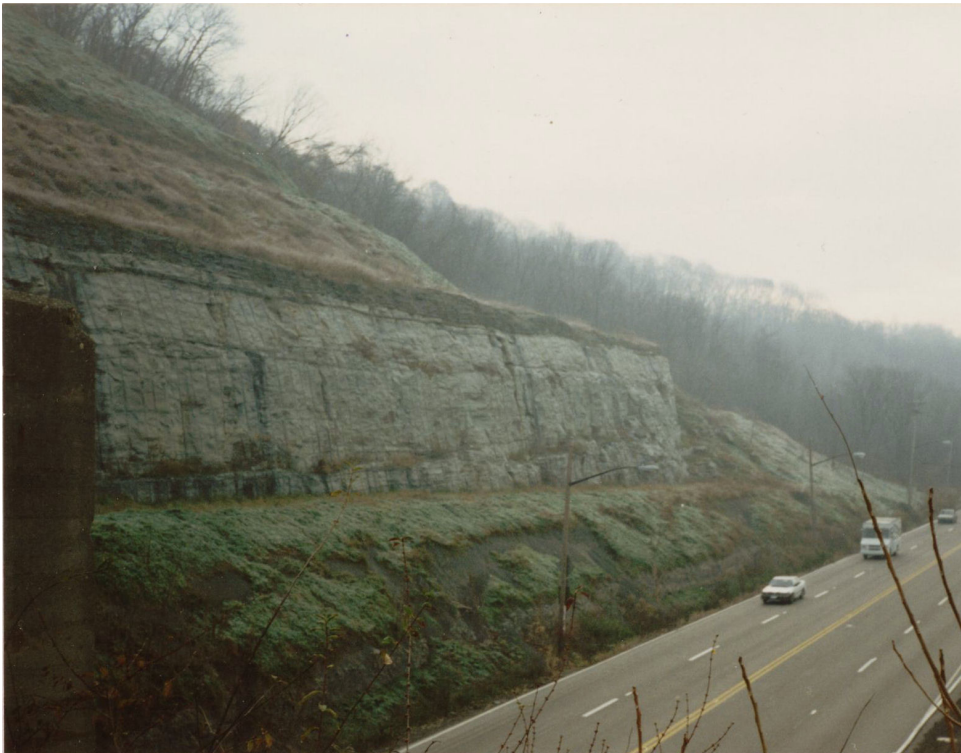
Rock slope following completion of D'Appolonia designed repairs.

The reconstruction of the slope was successfully completed without further incident and has remained stable since the completion of the project.
