PROJECT PROFILE

BLUE TRAIL LANDSLIDE STABILIZATION ON U.S. ROUTE 26/89 IN WYOMING

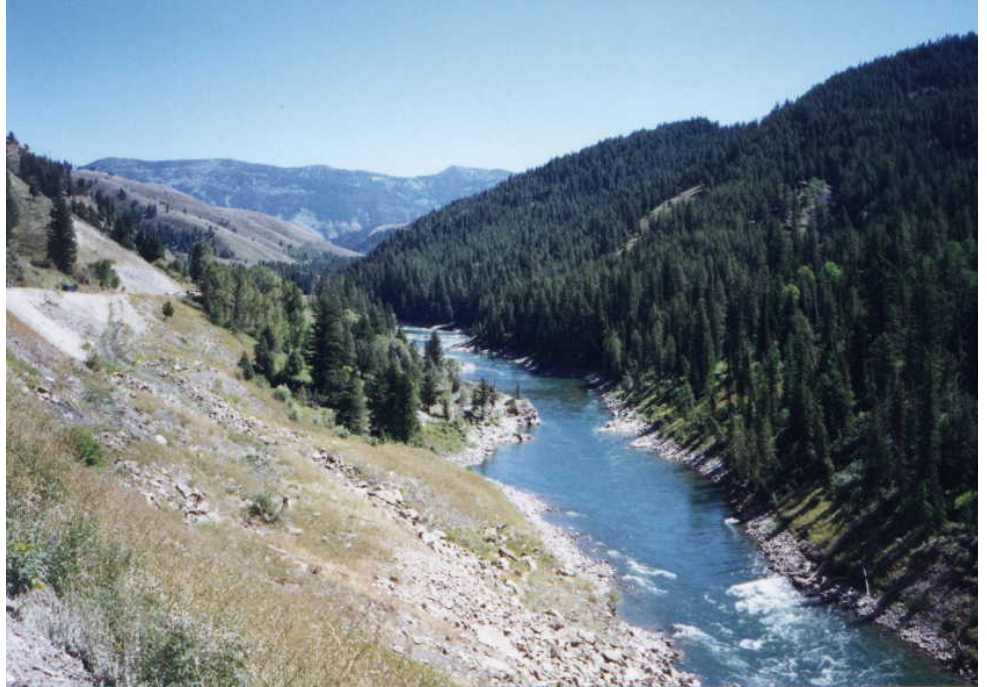
Pre-construction photograph showing the physical constraints at site.

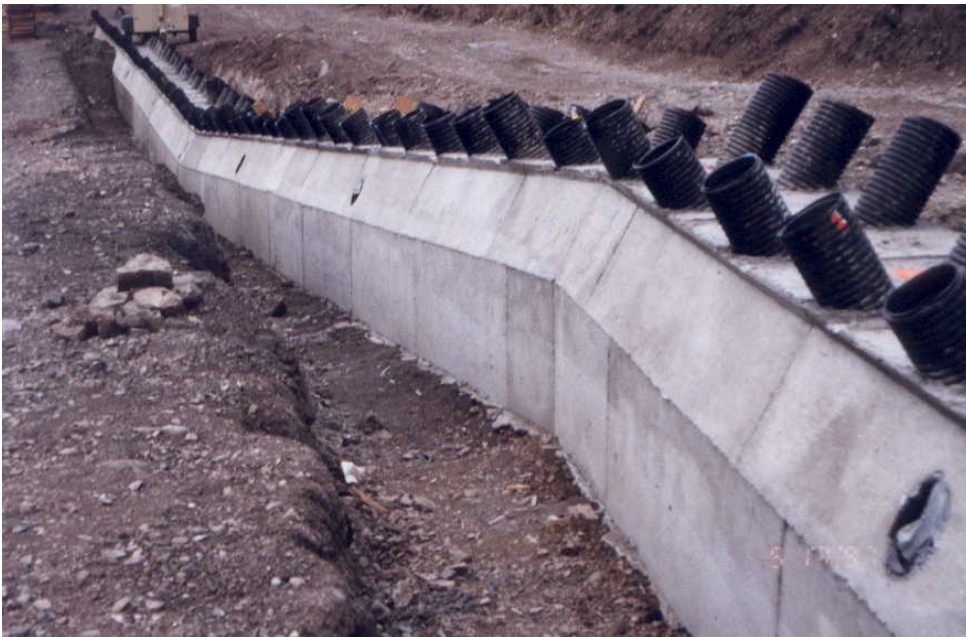
Reinforced concrete cap beam showing access for micropiles and anchors.

As the engineer/designer for Hayward Baker, Inc., D'Appolonia developed a repair scheme incorporating a three-tiered configuration of reticulated micropile walls. The walls consisted of uphill and downhill battered micropiles extending to below the slide surface and socketed in bedrock. At the ground surface the micropiles were connected by a continuous cast-in-place, reinforced-concrete cap beam. Prestressed 10- to 18-strand ground anchors were then placed through the cap beam and bonded into competent bedrock below the slide surface. Construction was performed along very steep slopes on an active landslide.

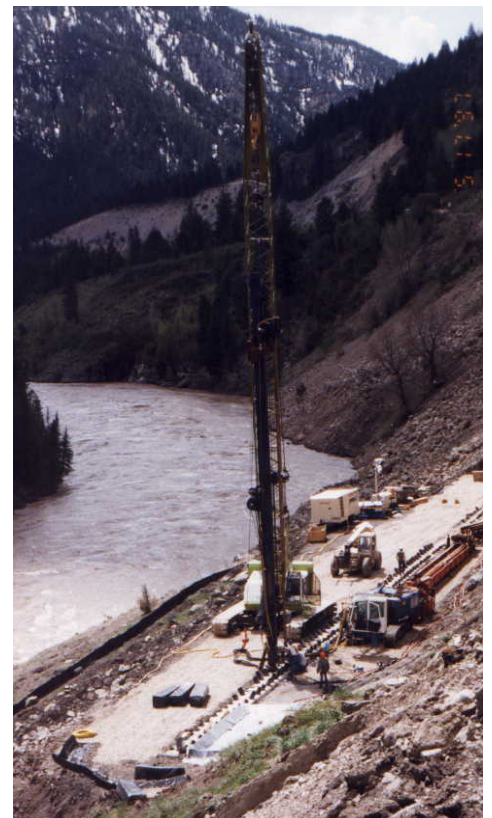
Micropile drilling operation.
