PROJECT PROFILE

HIGHLAND PARK RESERVOIR EMBANKMENT REPAIR

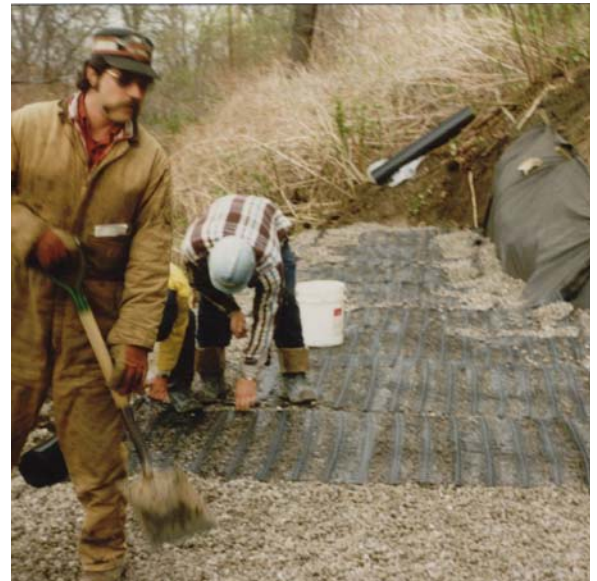
Placement of geogrids during reconstruction of the reservoir slope and bench for railroad track.

D'Appolonia was retained by the City of Pittsburgh Department of Engineering (City) to perform a subsurface exploration program and to develop corrective measures for the bench supporting the railroad. D'Appolonia designed and supervised the construction of a geogrid-reinforced granular buttress to remediate the damaged slope and restore the bench on which the railroad track was located.

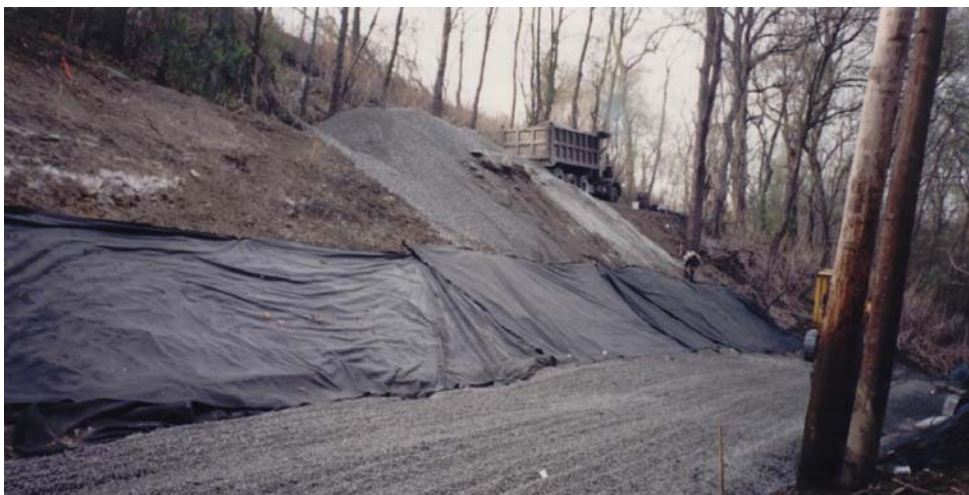
In 1987, the reservoir was drained to remove sediment from the bottom and to repair the concrete liner. As the reservoir was subsequently being refilled in 1988, a failure occurred along the downstream slope of the embankment, resulting in the destruction of a 160-foot segment of the zoo railroad, which was located on a bench approximately halfway down the impoundment slope from the crest. The failure was apparently caused by elevated ground water levels in the downstream face of the embankment resulting from seepage.

Reconstruction of 160-foot-long section of failed reservoir embankment.
